# River Lavant Condition Assessment and Walkover Survey Report

April – May 2024

Prepared for: The South Downs National Park Authority

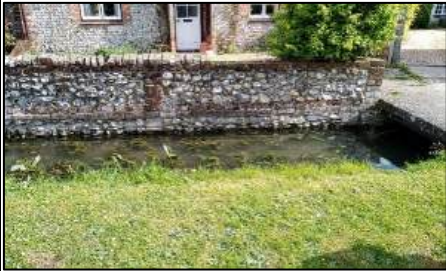
<p>Modified reach, partly reinforced channel</p>	RL05

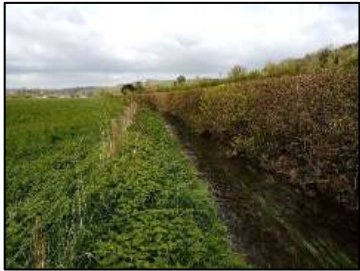
<p>River confined by Charlton road on right bank. Appears slightly perched with homogenous banks and considered likely to have historically been realigned to follow edge of field and managed for drainage.</p>
RL02b

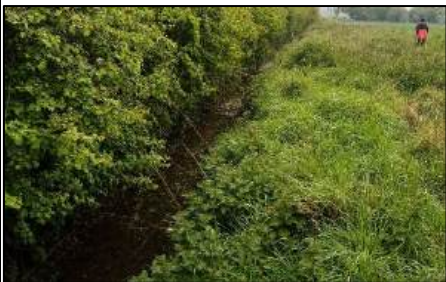
<p>Over deep with trapezoidal banks where adjoining gardens and Charlton Road</p>	RL09

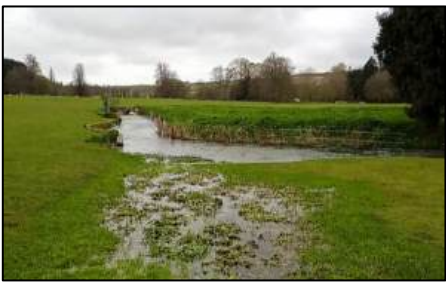
<p>Trapezoidal and reinforced banks. River appears slightly perched at lower end suggesting historical realignment.</p>
RL03

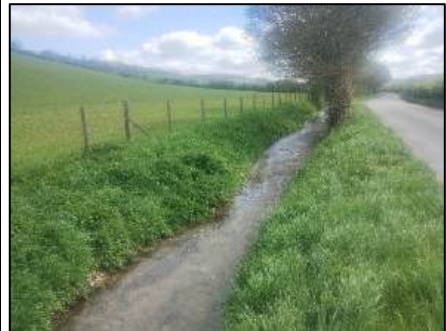
<p>Likely modified course of river along Charlton road with trapezoidal banks &amp; homogenous bed.</p>	RL10a

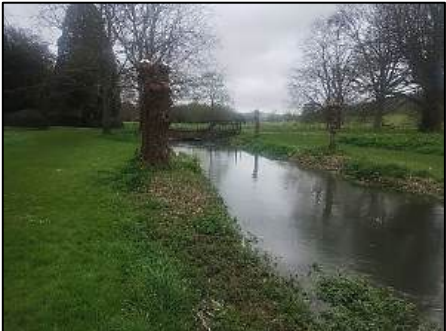
<p>Obviously reshaped banks in places and resectioned with weirs through West Dean gardens</p>
RL04

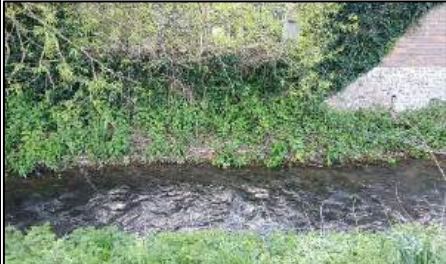
<p>River confined by wall and road at upstream end with modified steep reshaped left bank through horse paddock.</p>	RL18

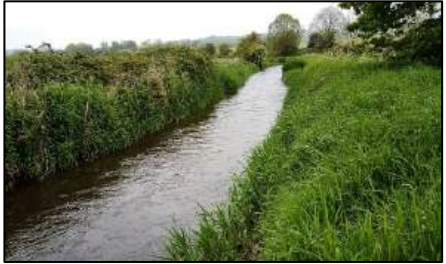
<p>Historically realigned and right bank raised as river flows past Mid Lavant.</p>

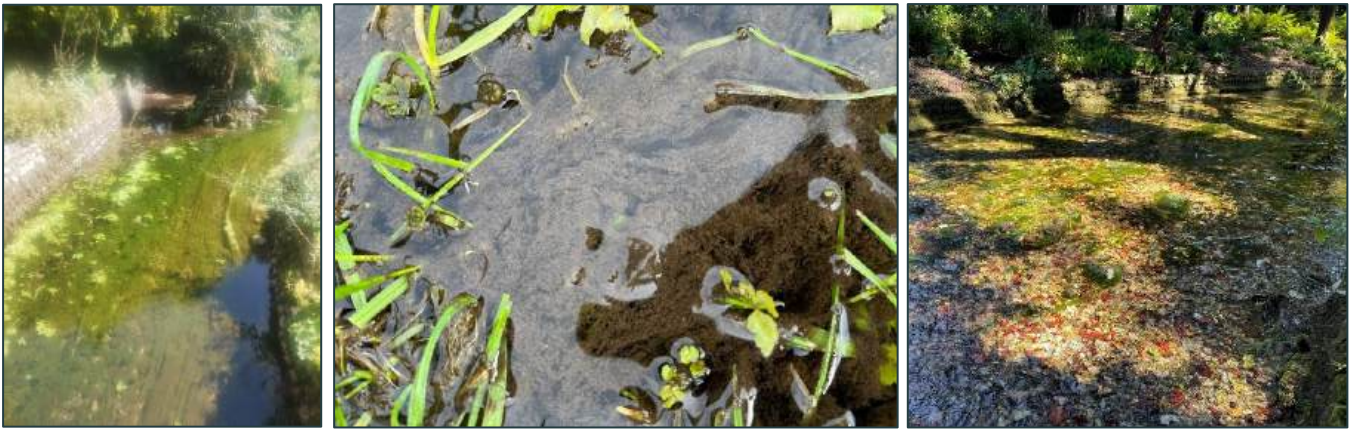
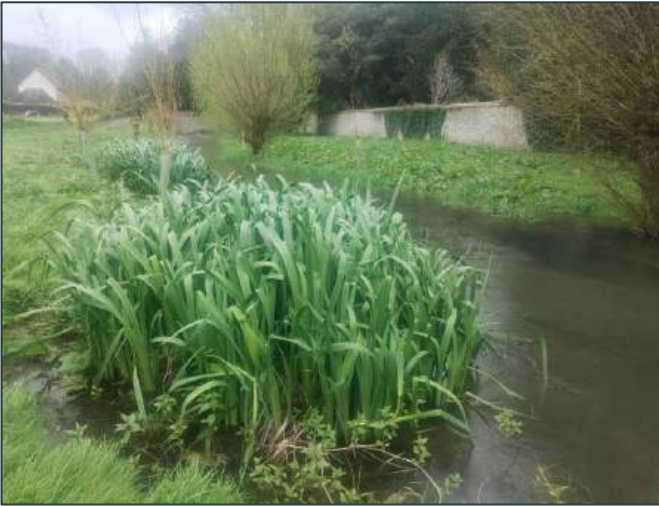
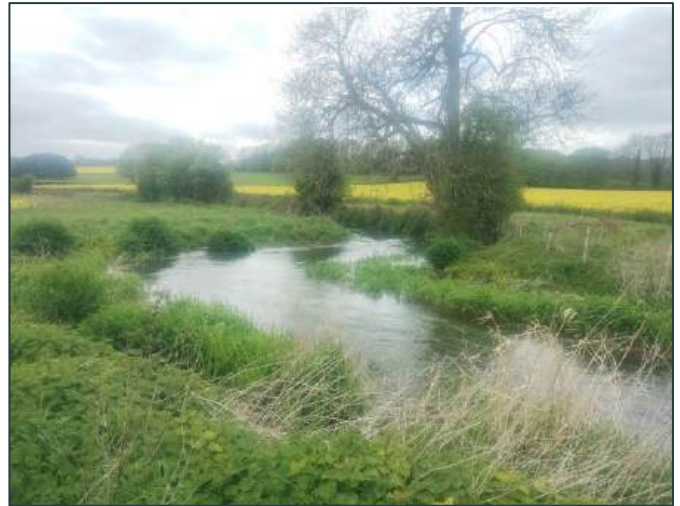
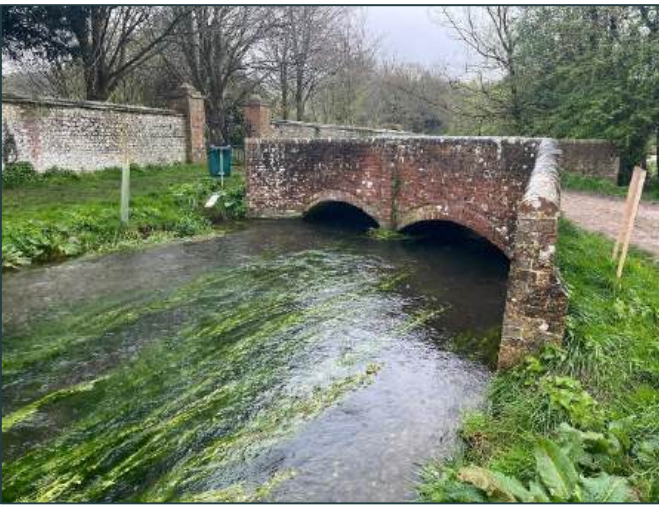
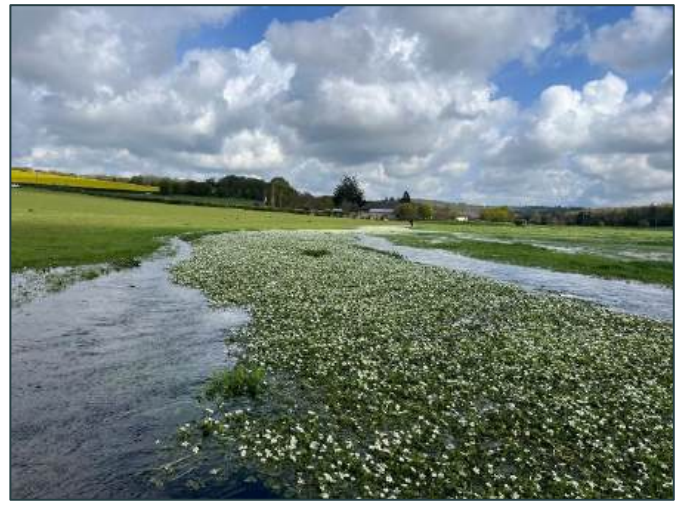
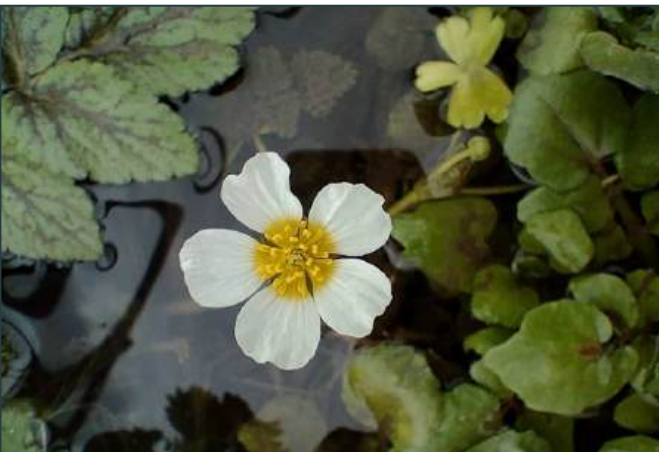
Plate 5; Photos showing examples of macrophytes observed during the walkover survey: from left to right top to bottom; *Cladophora* (blanket weed, RL10a, sewage fungus (RL13b)); *Hildenbrandia* (RL10a); *Iris pseudacorus* (RL10b); *Phalaris arundinacea* & *Oenanthe crocata* (RL12a); *Ranunculus* beds (RL10b and RL13b); *Ranunculus peltatus*, *Rorippa aquaticum* & *Apium nodiflorum* (RL13b); *Ranunculus* beds (RL13b); *Oenanthe crocata* (RL17).

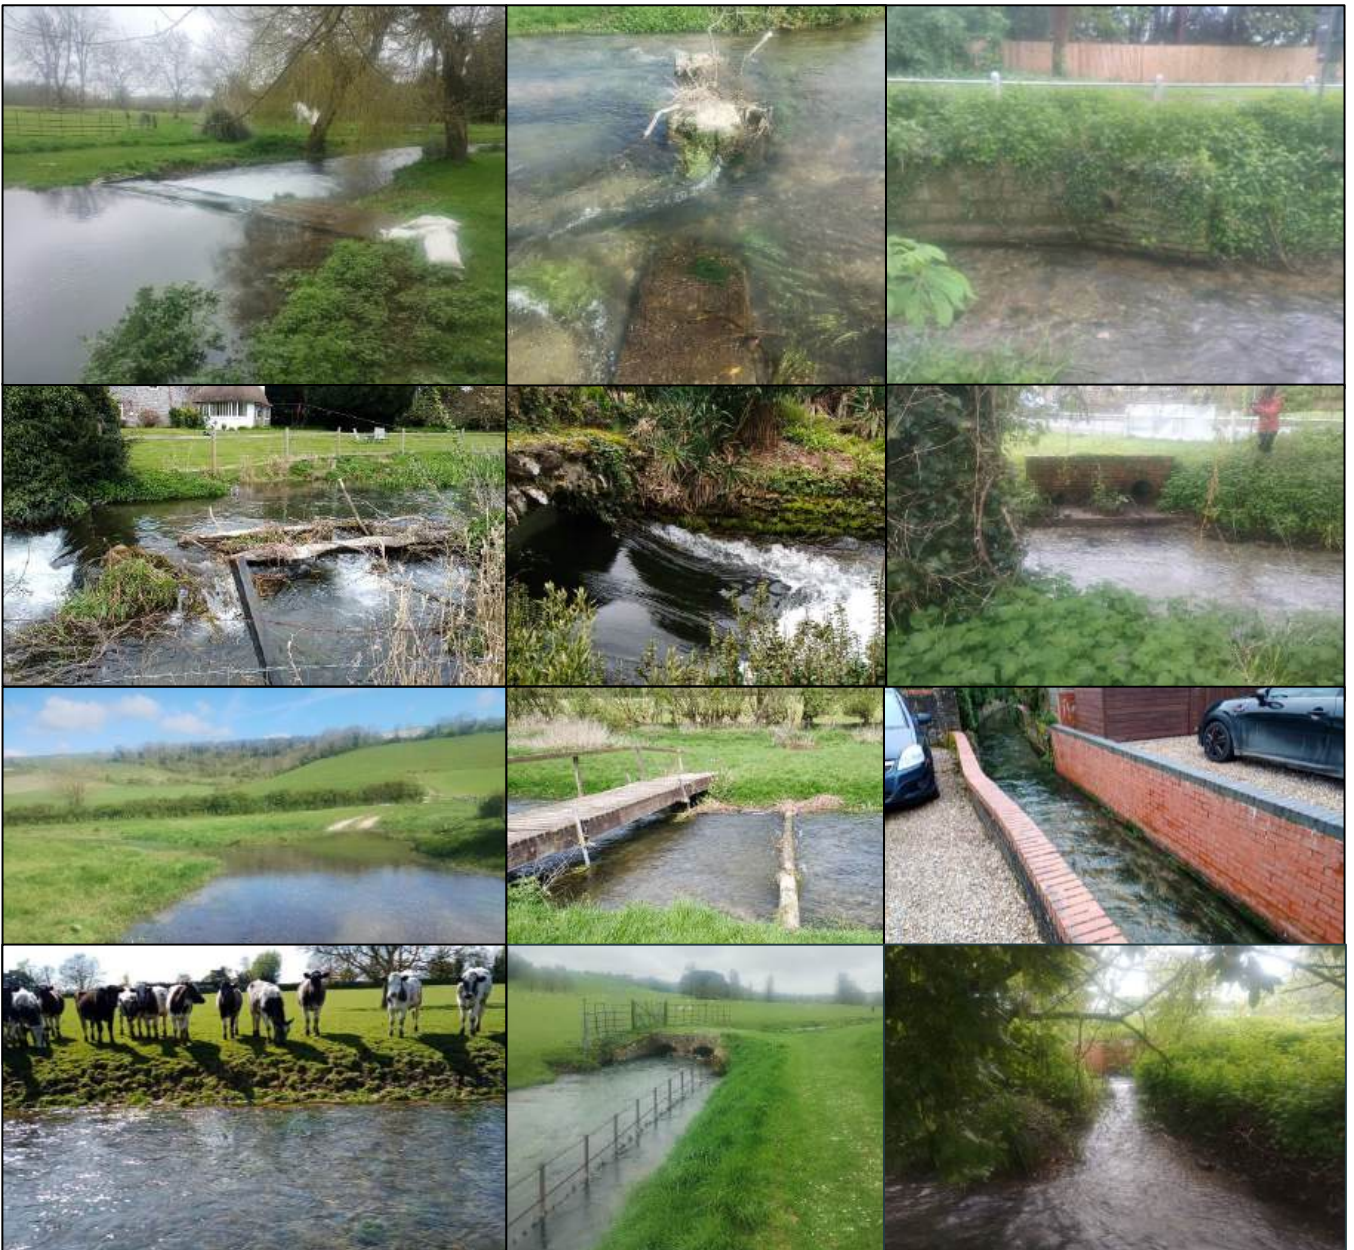
Plate 6 Photos showing examples of modifications recorded along the upper River Lavant from left to right, top to bottom: weir (RL10), major deflector (old sluice, RL07), minor outfall and reinforced left bank (RL06), major deflector (undercut weir, RL08), minor bridge, weir and reinforced banks (RL10), intermediate outfall (RL06), minor ford (RL02), minor bridge and minor (kiddies) weir (RL07), reinforced banks (RL06), poached river banks (RL15), culvert and resectioned banks (RL09), intermediate outfall (RL06).

Together, these modifications resulted in four sections being classified as severely modified, seven sections as significantly modified, four sections as obviously modified, and two sections as predominantly unmodified (Figure 14). The impact of modifications on the final numerical condition scores can be seen in Figure 15 which shows subreaches with more modifications generally have lower numerical condition scores, reflecting poorer habitat quality.

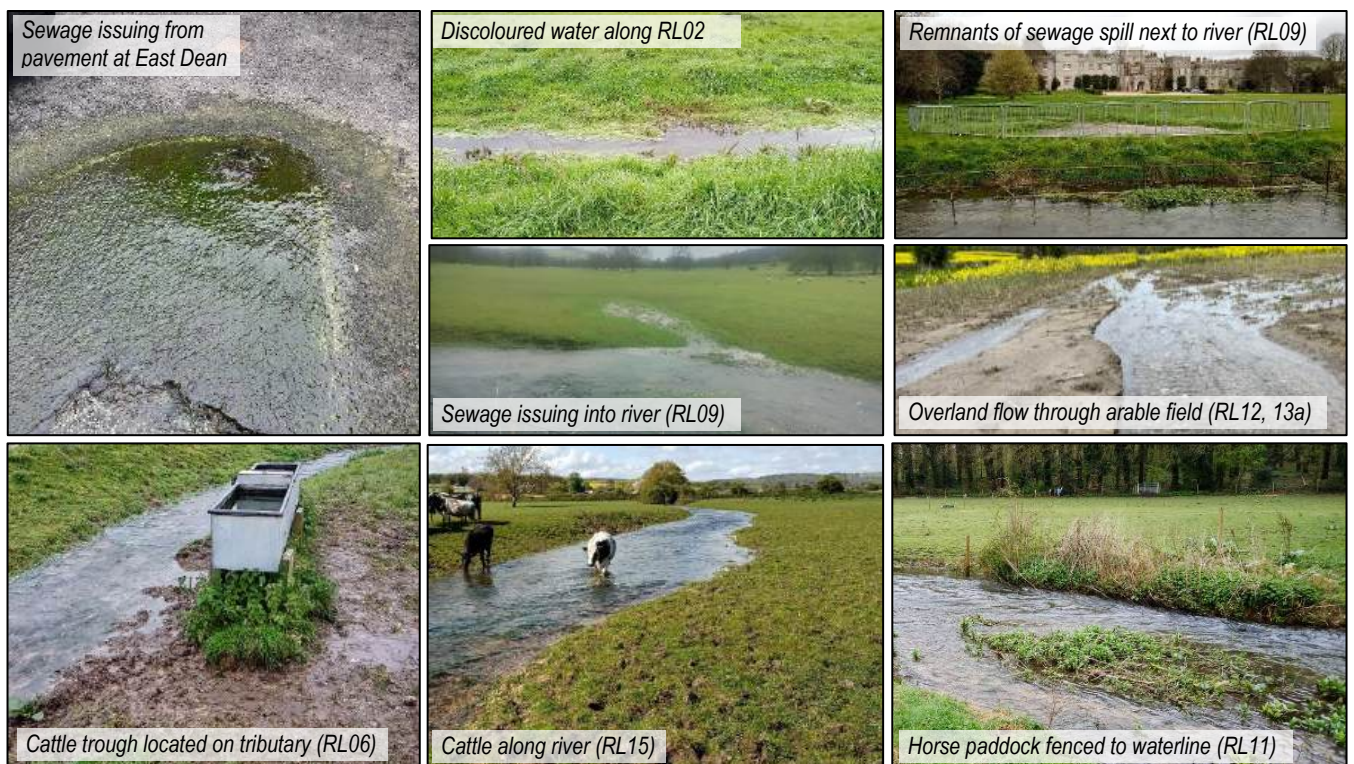
- Sewage issuing from drains at 11 locations along sections RL01, 02, 05, 07, 09, 10 and 17 with discoloured and/or foul-smelling water noted along sections RL01, 02, 05 and 10.
- Open drain cover submerged within riverbed in section RL13b.
- Horse manure pile on left bank top of river in section RL11.
- Diffuse pollution pathways from cattle and horse grazed pasture (RL04, 06, 11, 15).
- Diffuse/sediment pollution from overland flow through oilseed rape fields (RL12, 13a).
- Sediment pollution from muddy fords (RL02a, RL06)

Plate 7; photos showing examples of pollution pathways observed during the surveys.

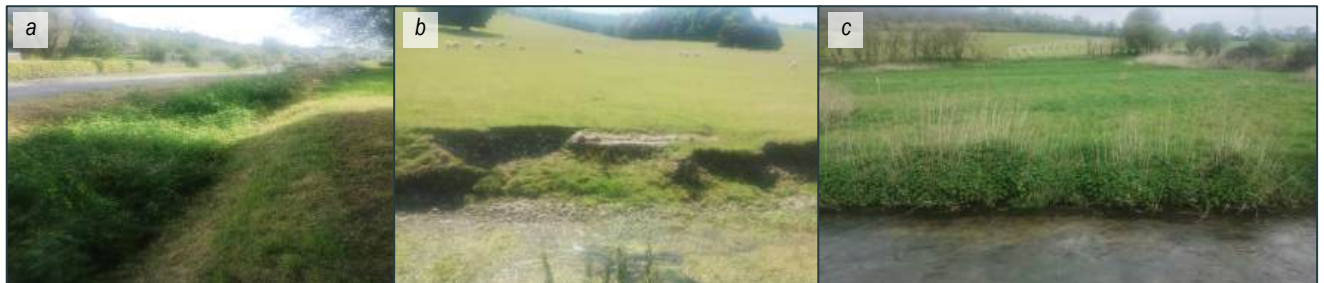
- Nine sections were considered to be impacted to some degree by grazing and/or livestock poaching and included three sections where livestock had access to a significant amount of the river (RL09, 13b & 15) and one section (RL08) where damage had occurred along localised sections of the watercourse. The remaining sections (RL03, 04, 06, 11 & 14a) were where livestock fencing was positioned close to the bank top or water's edge and considered to be limiting marginal habitat (Plate 8b).

- Common nettle along the riverbanks was widespread but was present in significant patches along eight sections (Plate 8c). Often associated with nutrient enrichment and bare areas trampled by livestock, the plant spreads by rhizomes to form dense patches, suppressing the growth of more diverse flora. It will also die back overwinter decreasing the resilience of the riparian margins to capture storm run-off from adjacent land.

Plate 8; a) showing mown banks along Charlton Road (RL05); b) livestock poaching (RL09); c) continuous nettle along bank face (RL07)

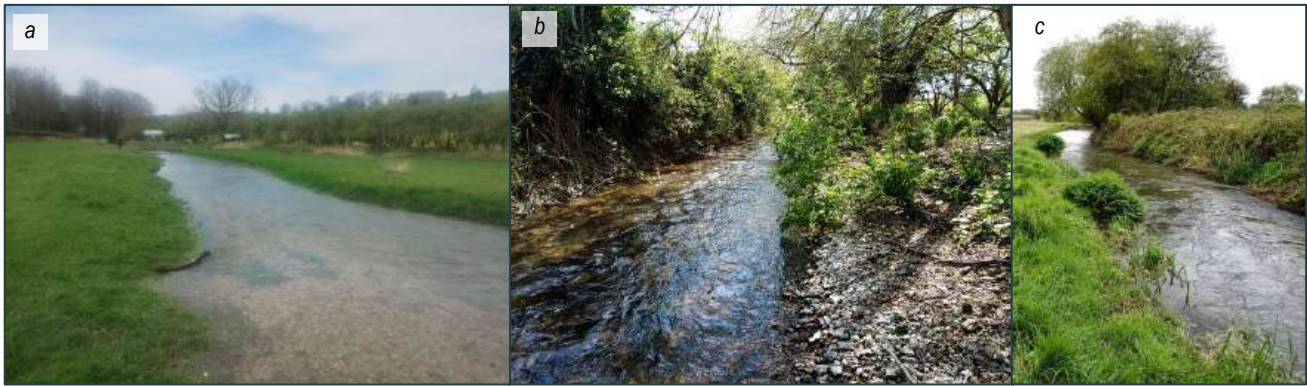
- Four subreaches were considered to be wholly or partly impacted by the absence of bankside trees and/or scrub such that the river was under-shaded and had few or no woody features to provide hydrological and physical diversity (Plate 9a).
- Five subreaches were considered to be partly overshadowed by trees or by scrub encroachment (Plate 9b).
- The riparian margins along two subreaches were considered to be impacted by dominance of bramble scrub that was limiting diversity of marginal macrophytes and habitats (Plate 9b).

Plate 9 a) under shaded and homogenous (RL07); b) overshadowed by trees and scrub (RL14b); c) homogenous scrub on right bank (RL17)

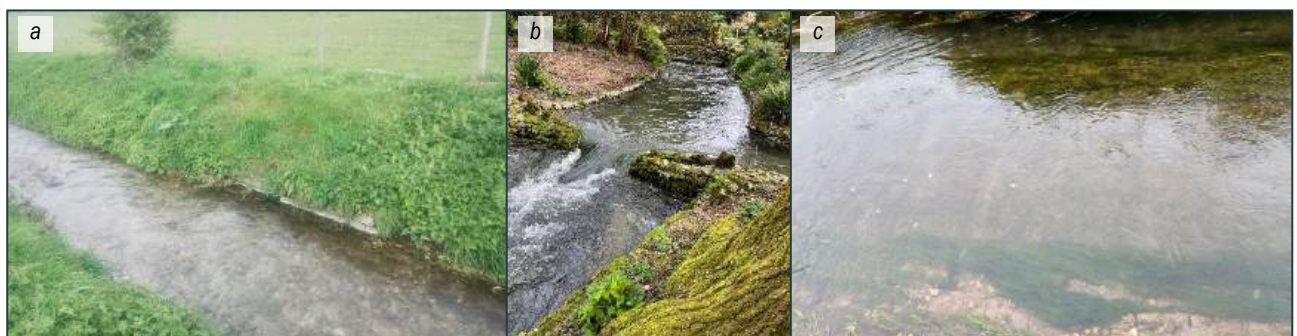
Likewise, bed reinforcements which were recorded in two sections (RL10a, & 18, Plate 10c) create a resistant layer which reduces the ability for specialist invertebrate species to access water-filled interstices in sediments which are important refuge areas during the dry phase. Where bed reinforcement encroaches into the water column, these impound water and trap sediment, altering habitat diversity and river dynamics, and can create artificial flow regimes (such as the creation of eddy's) which can exacerbate erosion.

*Plate 10 a) small bank toe reinforcements (RL03), b) major bank and partial bed reinforcements (RL10a); c) bed reinforcements associated with old footbridge (RL18)*
