Defra River Improvement Fund Phase 3: Final Report

Project Ref	RT320
Rivers Trust	OART
Project Title	Costers Brook Connectivity Project
Period ending	October 2012

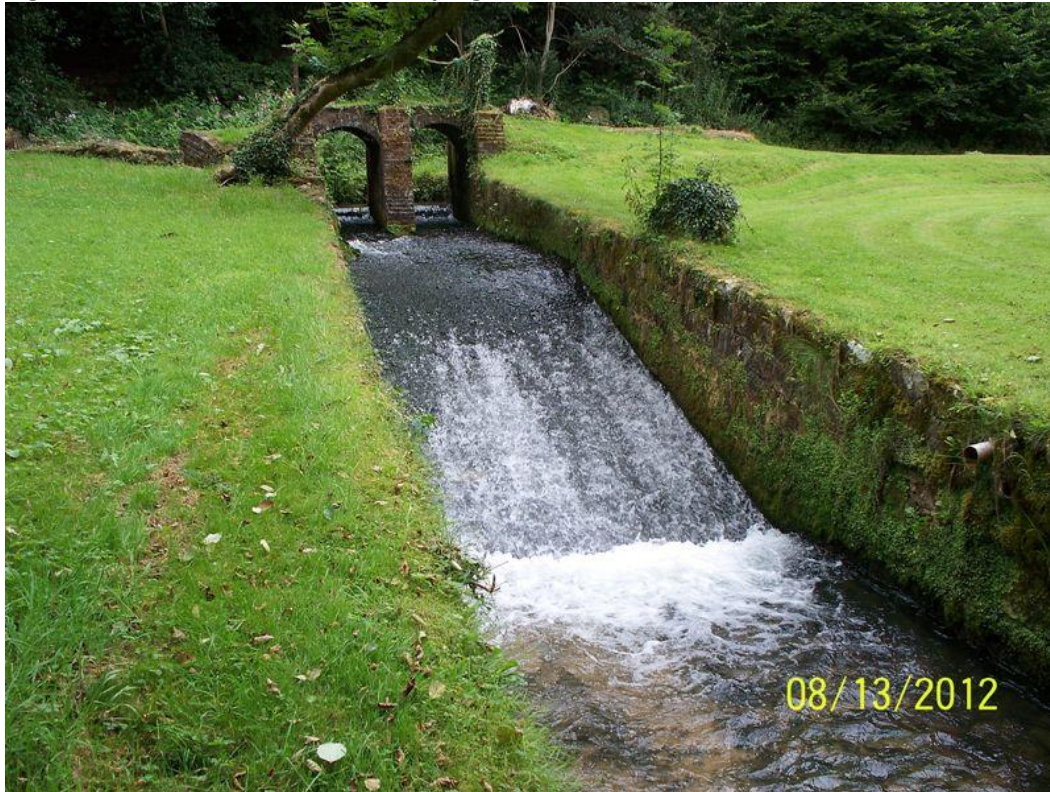
Figure 2: Before the works - the sloping weir built within the stone mill leat on the Costers Brook

Prior to the works the mill weir was regarded as almost a complete barrier to migratory fish, with both brown and sea trout frequenting the catchment. The weir has a total head-drop of 1.5m, is 3m wide, and is set at a 25% gradient. Water flows quickly down the shallow weir face, making it difficult for fish to pass. Furthermore, stop logs upstream of the weir, beneath a footbridge, create a further barrier to fish migration. The stop logs create an approximate 200mm head drop and the water flows across a shallow cill beneath the bridge, likely to be impassable for most fish. Even when there are relatively high flow conditions in the Brook the water is still very shallow across the weir face with depths on the crest of less than 70mm. It is unlikely that migratory salmonids would be able to pass the weir with depths of less than 100-150mm.

The evaluation of easement options for the site revealed that both a Larinier fish pass and a low-cost baffle easement would improve fish passage and leave approximately two thirds of the weir face free. The

oak baffle option was considered preferable because it is less conspicuous and blends in better with the surrounding environment. Moreover, the oak baffles can be simply bolted onto the face of the weir without any modification to the weir face, whereas the Larinier pass would require modification of the weir face in order to reduce the gradient to the recommended maximum of a 15% slope, which was likely to conflict with the listed building status of the weir.

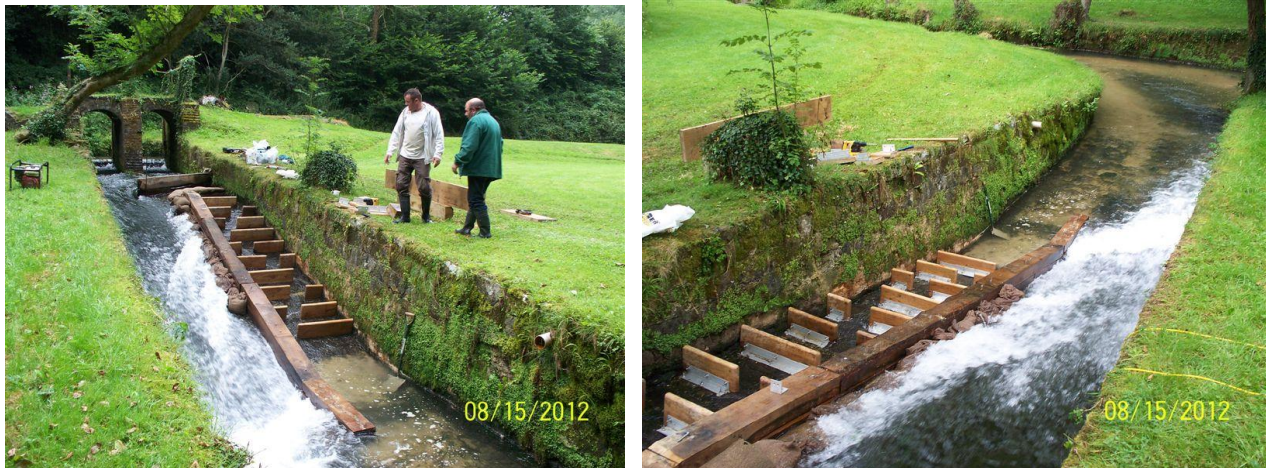
Figure 3: Installation of the oak baffle fish easement over the mill weir

Having secured a workable design with technical drawings, formal Listed Building Consent and also the EA Land Drainage Consent (LDC) required for the proposed works a number of potential contractors were contacted to provide quotations for delivery of the works. The work was awarded to Castleford Engineering Limited, which has a good record of implementing river based works. The proposed works were completed over four days in mid-August 2012.

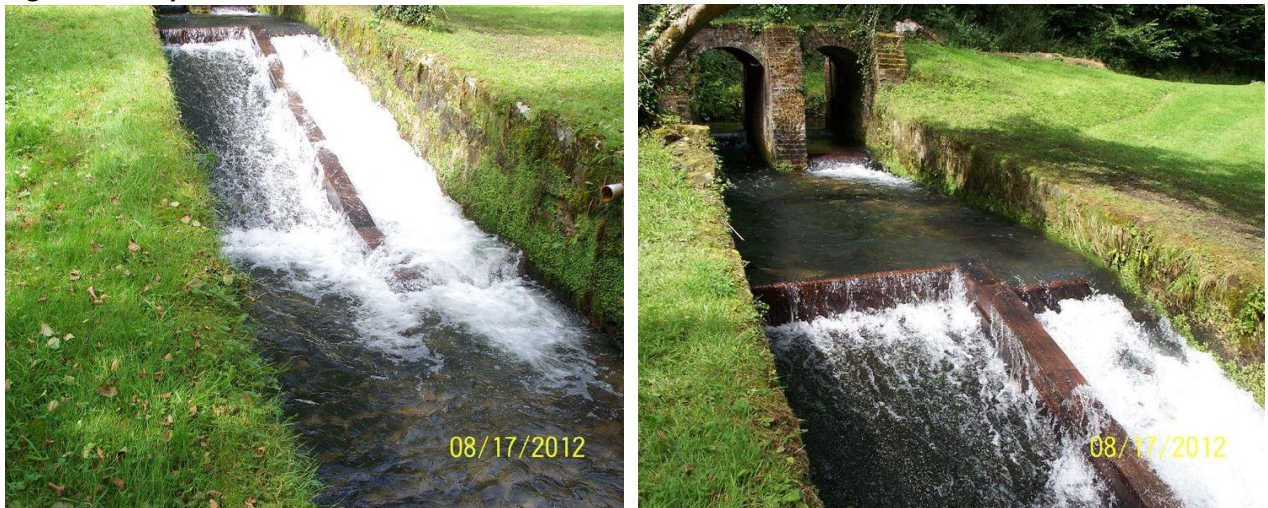
Figure 4: completed fish easement at the mill weir on the Costers Brook

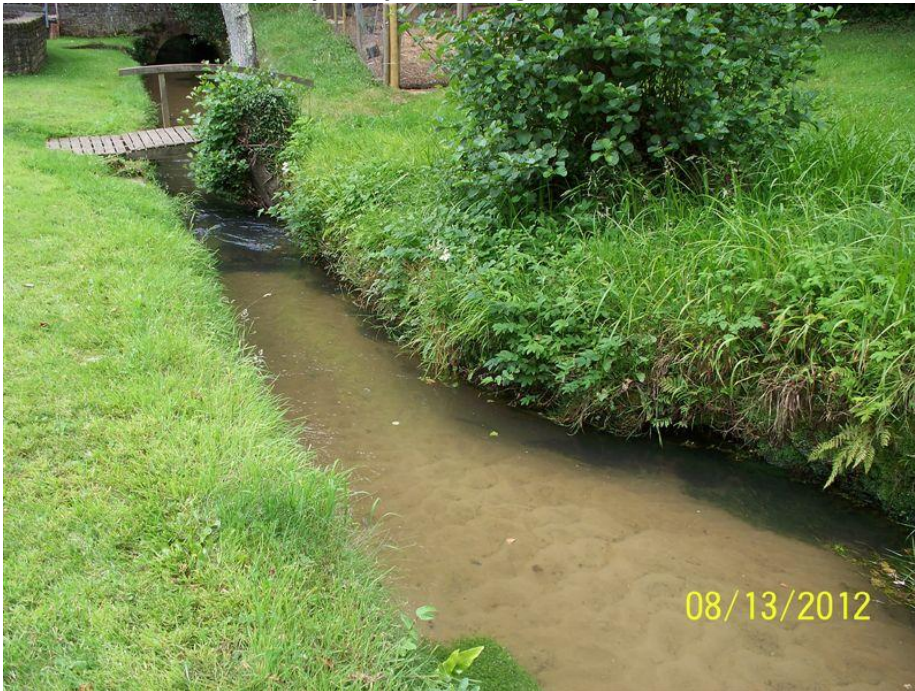
An agreed condition of undertaking the fish easement works requested by the landowner involved restoring part of a dilapidated mill leat wall just downstream of the weir, which over time had slumped forward into the channel. This was partly due to a number of fresh water springs located behind the stone wall for which no drainage outlet had been provided, subsequently pushing the wall forward and pinching the channel, the action of which was exacerbated by the erosional forces of the Brook.

Figure 5: Before the works – showing the original (wider) size of the mill leat and how it had slumped forward over time subsequently narrowing the width of the Brook

While it is debateable whether the re-instatement of the original mill leat wall is desirable from a fish passage point of view, the Listed Building status of the leat meant that any remediation works had to be in-keeping with the cultural heritage value of the site, which was itself in a domesticated garden setting. All the stone needed for the repair works was retrieved from the mill leat, having been buried over time by the sandy sediments; using the original Sussex block sandstone meant the re-instated wall blended in perfectly with the existing surroundings.

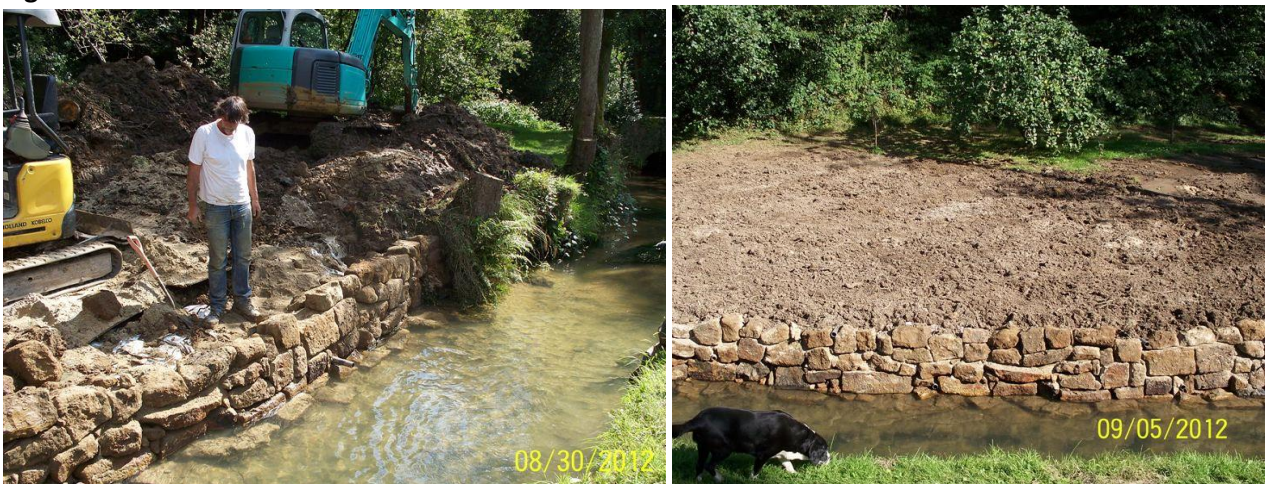
Figure 6: Re-instatement of the mill leat wall and the finished work

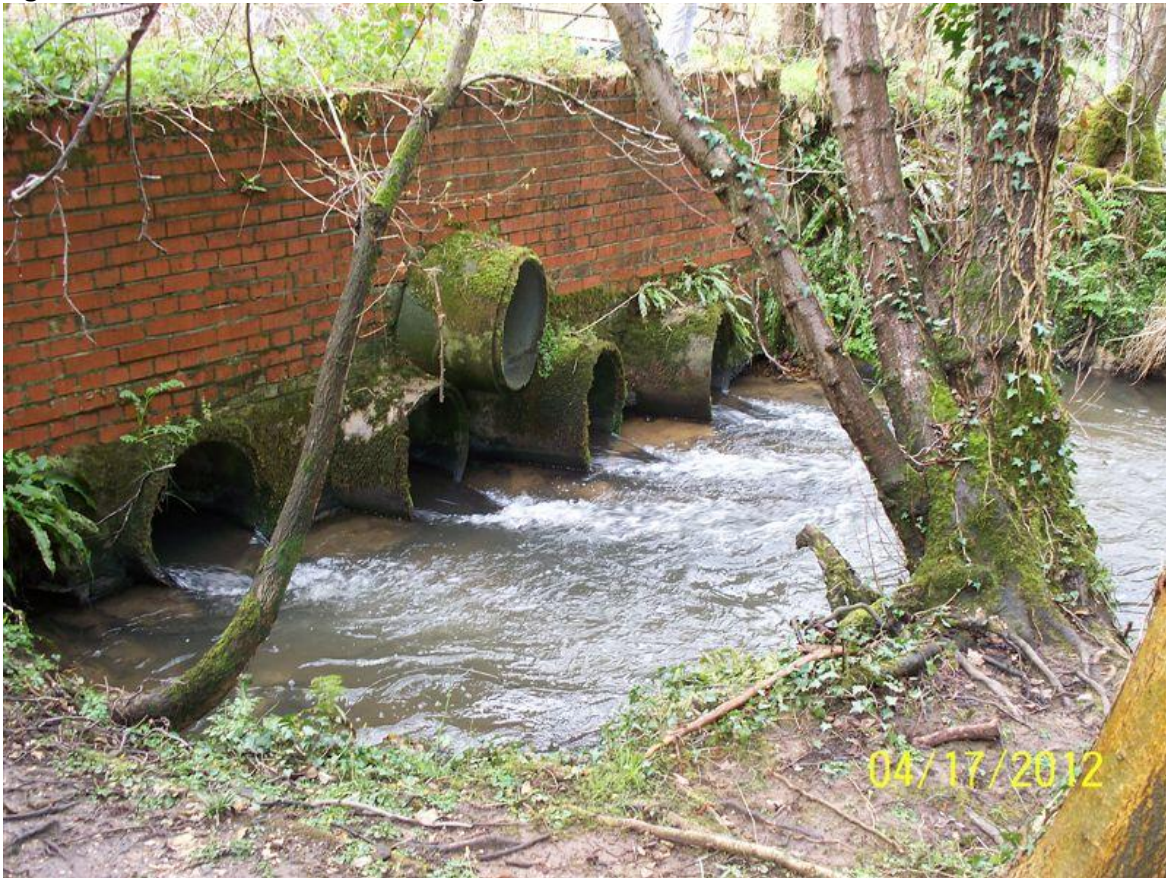
The culverted farm bridge comprises several concrete drainage pipes laid lengthways along the bed of the Costers Brook, with brickwork above to form the sides of the bridge. Under low flow conditions there is often insufficient water through the pipes to allow fish passage. During higher flows the water velocity can be too great to enable all but the strongest migrating fish to navigate the culverted bridge. This is particularly the case if one or more of the culverts become blocked by debris, which increases the velocity through the remaining pipes to the point at which it significantly limits fish passage. The proposal was to either replace the bridge with a clear spanning alternative, or to look into modifications to the site to improve fish passage over a wider range of flows than currently exist.

Figure 7: the multi-culverted farm bridge over the Costers Brook SU 89432 20135

Considerable work was undertaken to explore the potential for replacing the existing bridge with a free-spanning alternative, however, in conclusion of this work the landowner was happier to keep the culverted bridge in-situ and instead look at other means of improving fish passage. This was addressed by raising the stream bed level at the tail of the plunge pool immediately downstream of the bridge by constructing a rock and gravel ramp. The works were delivered by a local contractor experienced in delivering successful high quality river engineering and restoration projects, in conjunction with Andy Thomas of the Wild Trout Trust (WTT), who has many years' experience in both the design and delivery of river restoration projects. Approximately 20 tonnes of Sussex sandstone (of mixed sizes varying between 200-400mm width and length dimensions) was carefully placed into the Brook, top dressed with 20 tonnes of finer land-dug flint gravel rejects (~40-60mm diameter) to raise the water level of the plunge pool by approximately 200mm. The introduced stone and gravel were strategically located within the Brook, raising the water level through the culverts, creating new spawning habitat for all flow-loving fish species,

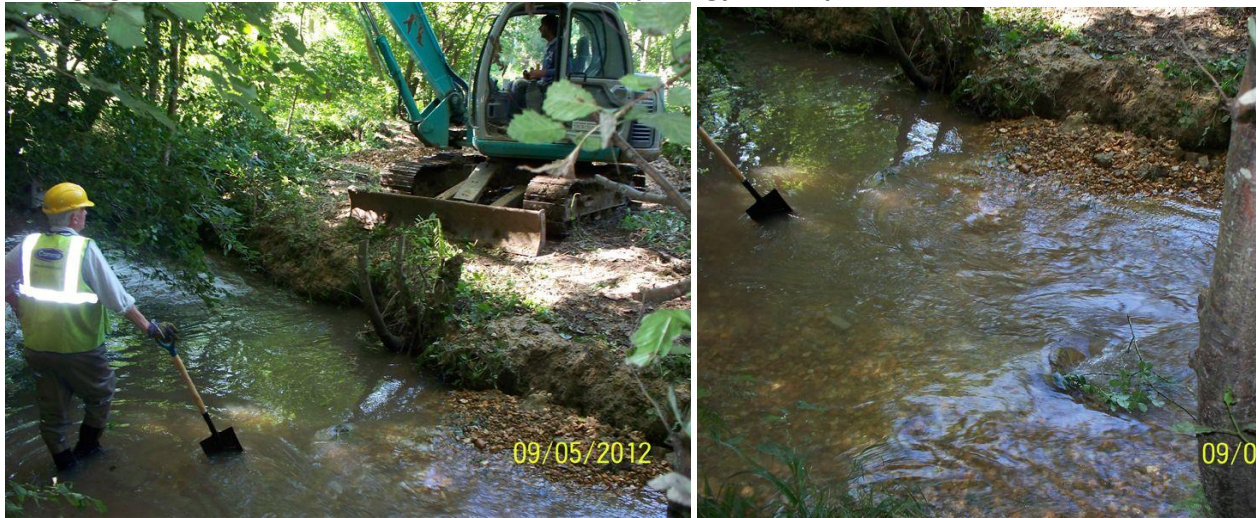
Figure 8: work in progress – introducing the flint gravel rejects on top of the larger stone boulders and arranging them to create more diverse channel morphology and improve flow

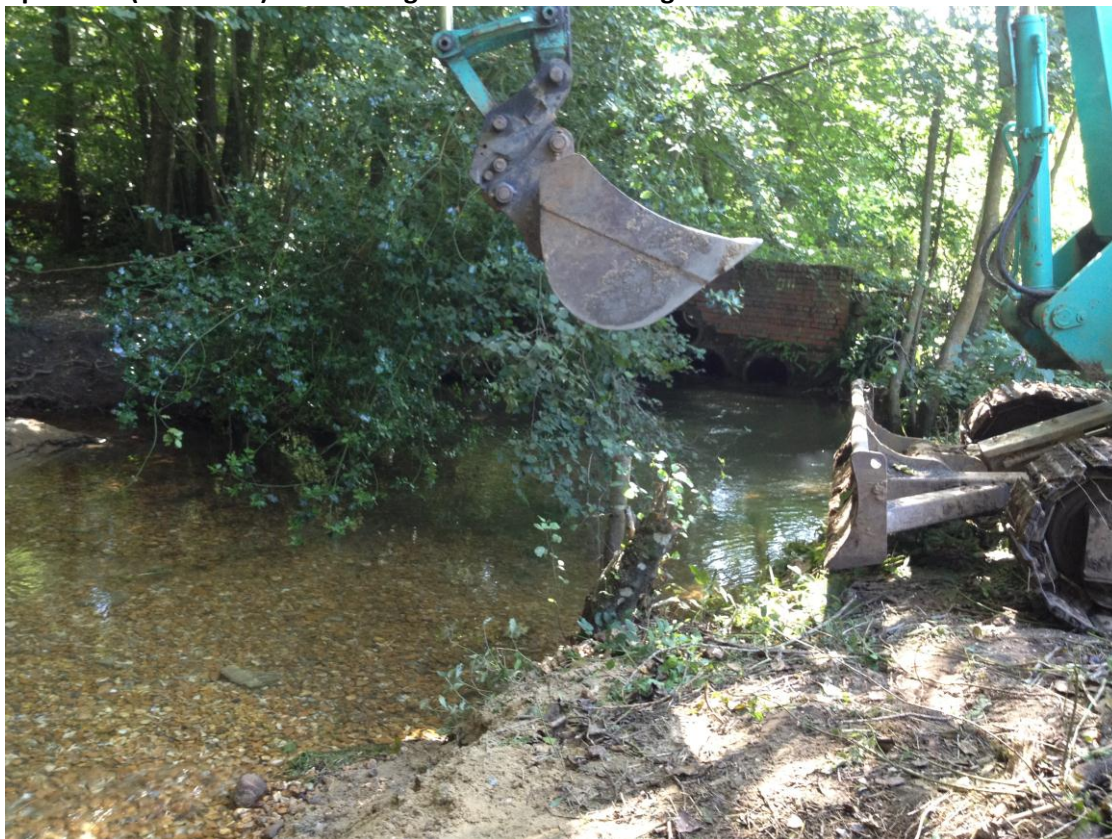
Figure 9: The new gravel habitat provides an additional spawning opportunity for a range of flow loving fish species and the higher water level through the culverted farm bridge ensures more fish can move upstream (and down) of the bridge across a wider range of flows

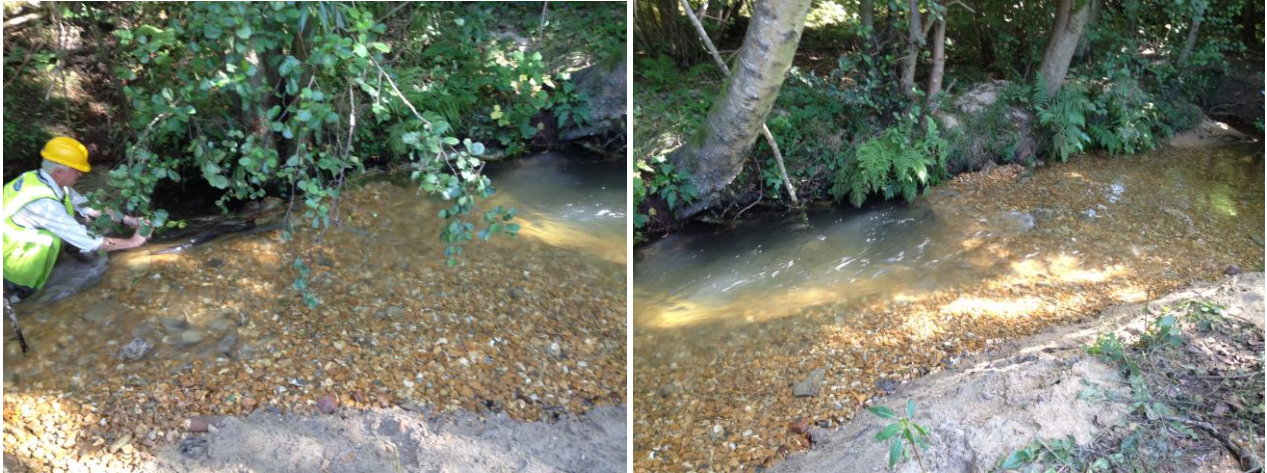
Figure 10: Creating a more diverse flow regime and additional habitats within the existing channel at the site of the new rock and gravel ramp
