# River Lavant Condition Assessment and Walkover Survey Report

April – May 2024

Prepared for: The South Downs National Park Authority

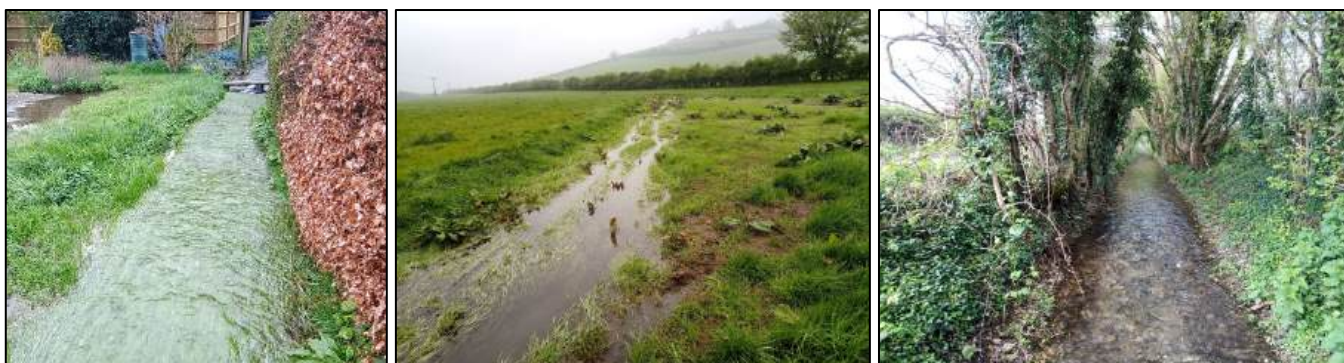
Plate 1: Photos showing general character of Reach 1 where left is subreach RL01, middle is subreach RL02 and right is subreach RL03.

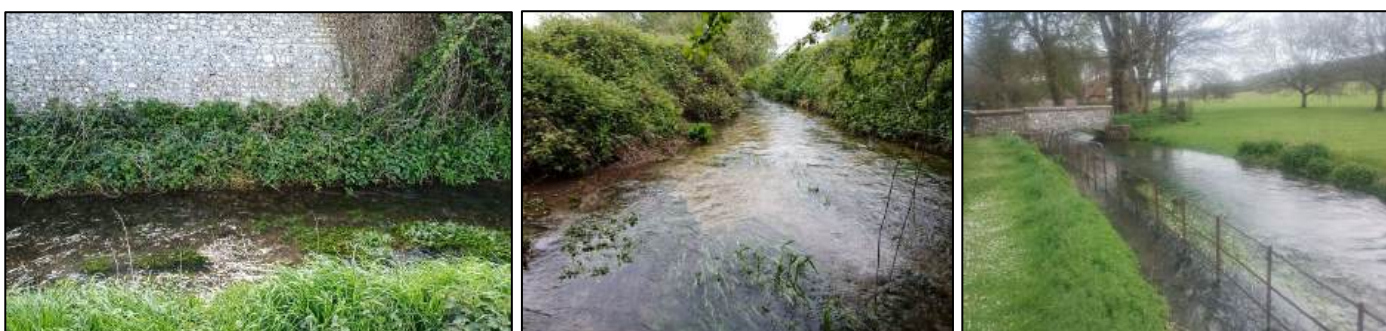
Plate 2: Photos showing general character of Reach 2 where left is subreach RL04, middle is subreach RL06 and right is subreach RL09.

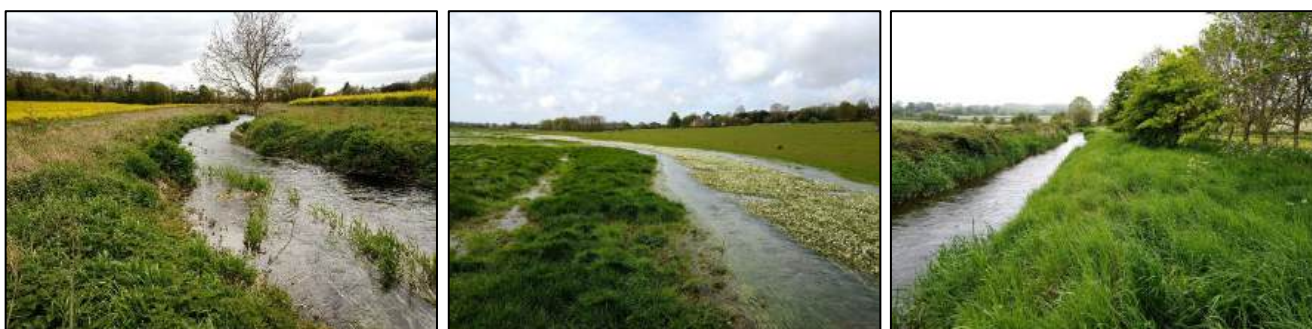
Plate 3: Photos showing general character of Reach 3 where left is subreach RL12, middle is subreach RL13b and right is subreach RL18

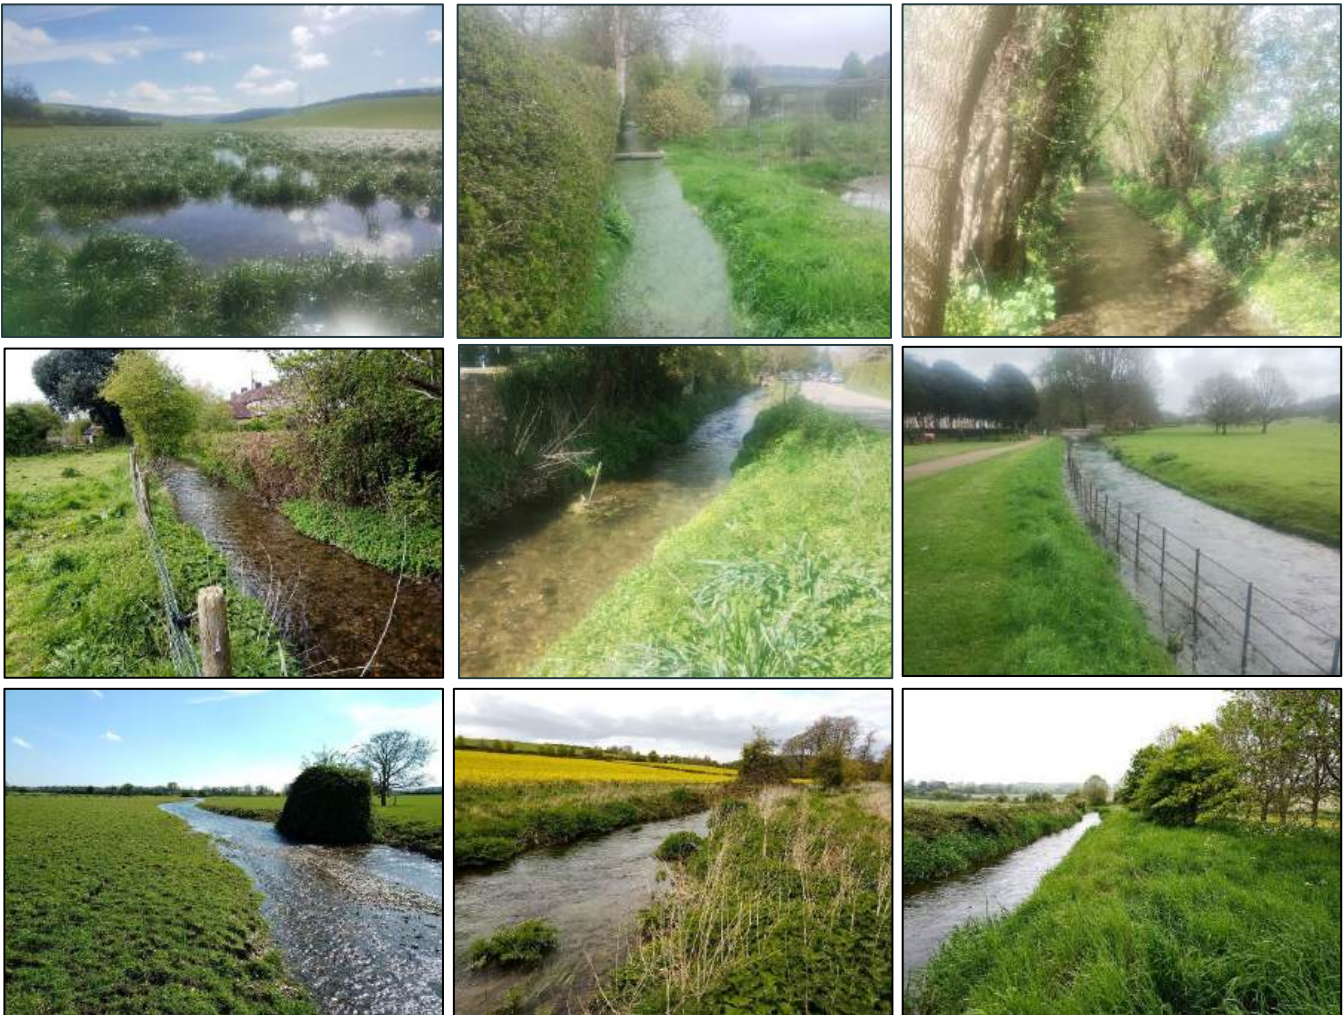
Plate 4: Photos showing riparian habitats encountered during the survey from left to right top to bottom: Improved grassland at source (upstream of RL01); allotments (RL01); line of trees (RL03); horse pasture (RL04); transport infrastructure (RL04); pasture and mown grass (RL09); cattle pasture (RL15); arable margins (RL12) and wide margin of pasture field (RL18).

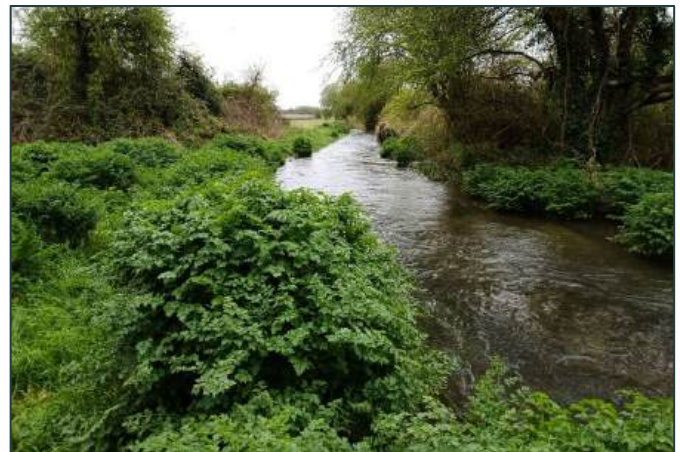
Plate 5; Photos showing examples of macrophytes observed during the walkover survey: from left to right top to bottom; *Cladophora* (blanket weed, RL10a, sewage fungus (RL13b)); *Hildenbrandia* (RL10a); *Iris pseudacorus* (RL10b); *Phalaris arundinacea* & *Oenanthe crocata* (RL12a); *Ranunculus* beds (RL10b and RL13b); *Ranunculus peltatus*, *Rorippa aquaticum* & *Apium nodiflorum* (RL13b); *Ranunculus* beds (RL13b); *Oenanthe crocata* (RL17).

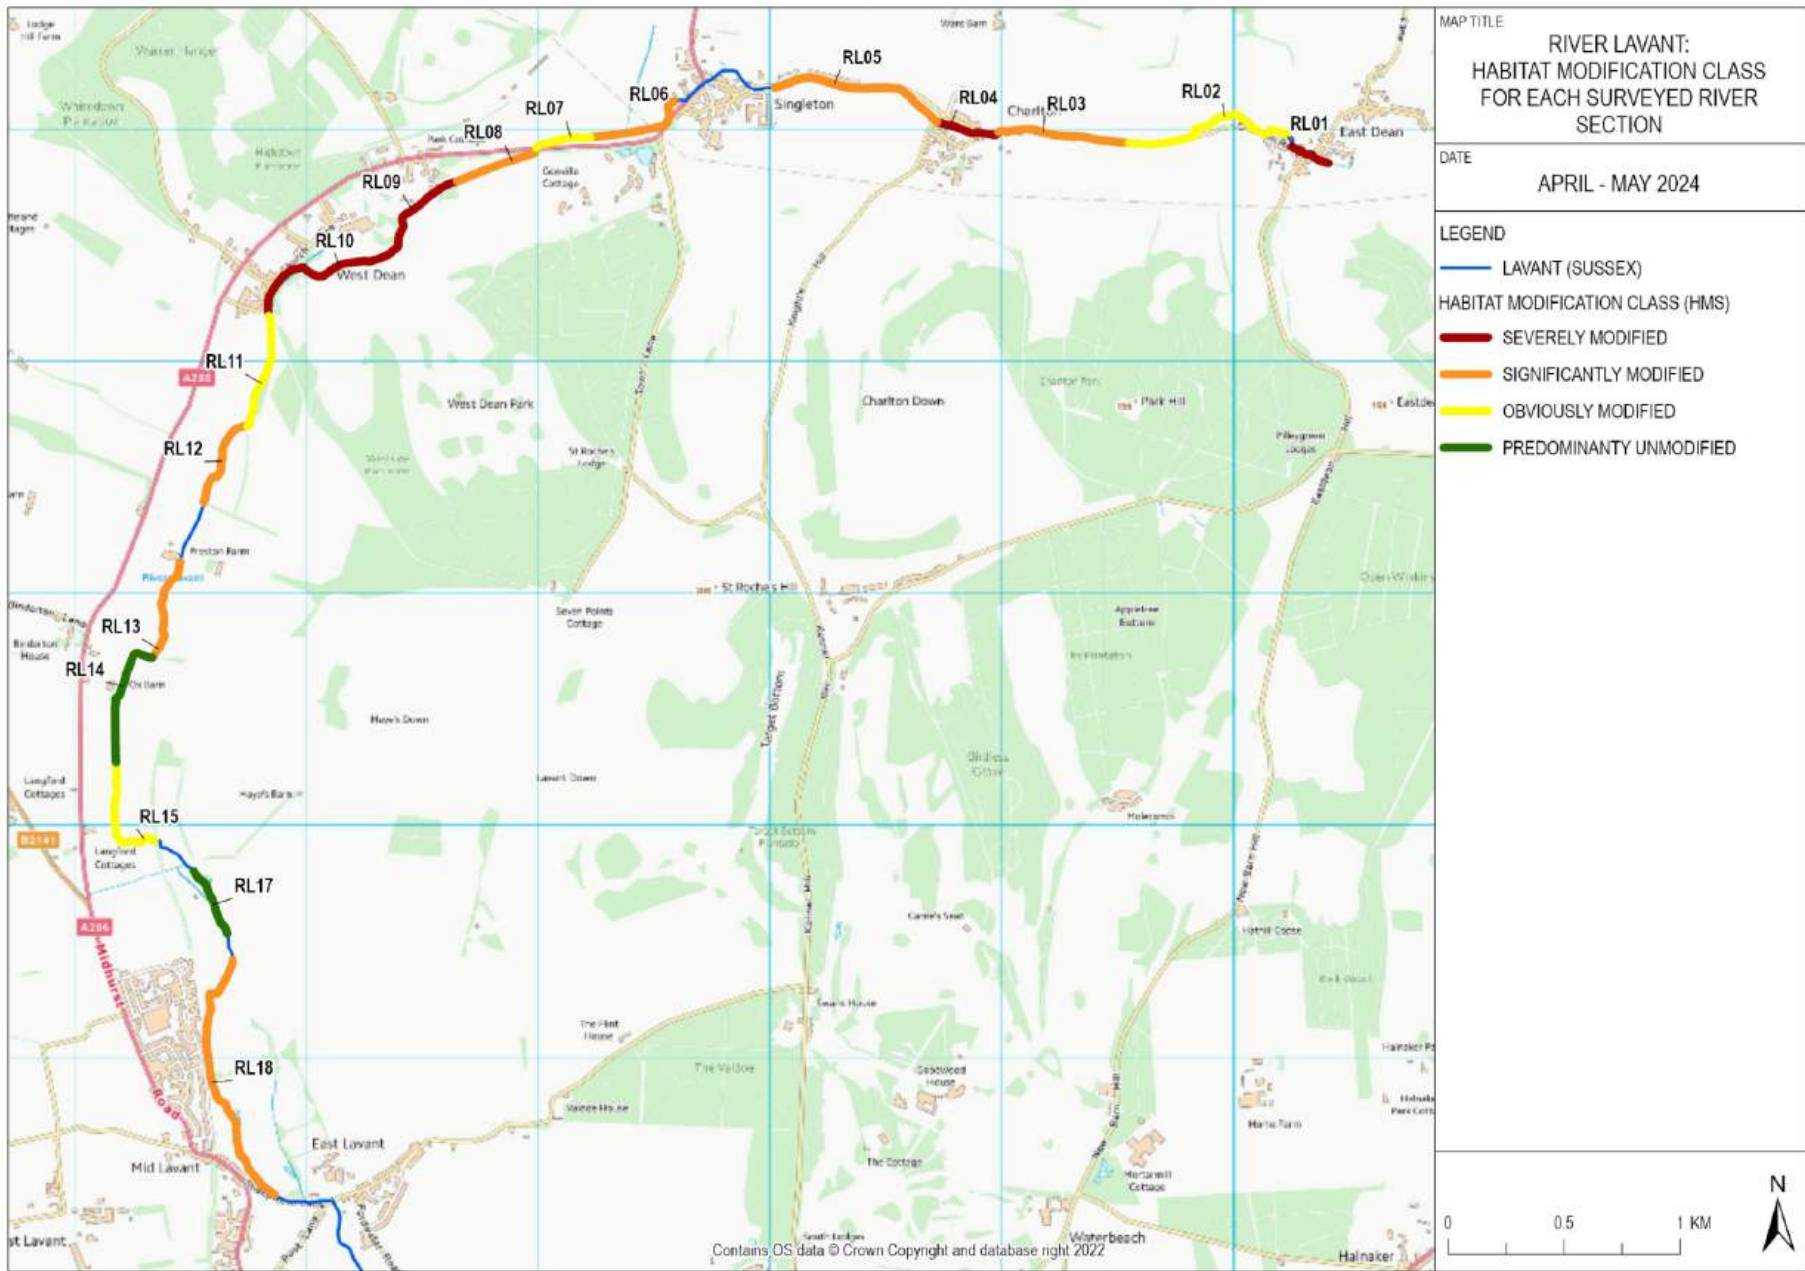
Together, these modifications resulted in four sections being classified as severely modified, seven sections as significantly modified, four sections as obviously modified, and two sections as predominantly unmodified (Figure 14). The impact of modifications on the final numerical condition scores can be seen in Figure 15 which shows subreaches with more modifications generally have lower numerical condition scores, reflecting poorer habitat quality.

Figure 16: Map showing the habitat modification class for each section of the upper River Lavant that was subject to a river walkover survey.
